Riparian Areas Regulation - Qualified Environmental Professional - Assessment Report

Riparian Areas Regulation: Assessment Report

Street Address (or nearest town)	Craig Bay Estates		
Local Government	City of Parksville	City	
Stream Name	Craig Creek		
Legal Description (PID)	VIP 70465 Lot C	Region	Vancouver Island
Stream/River Type	Stream/Wetland	DFO Area	South Coast
Watershed Code	920-457100		
Latitude	49	18	04 Longitude 124 14 51

Removal of hazardous trees at Craig Bay, VIS 5081, located at Northwest Bay Road in Parksville, B.C.

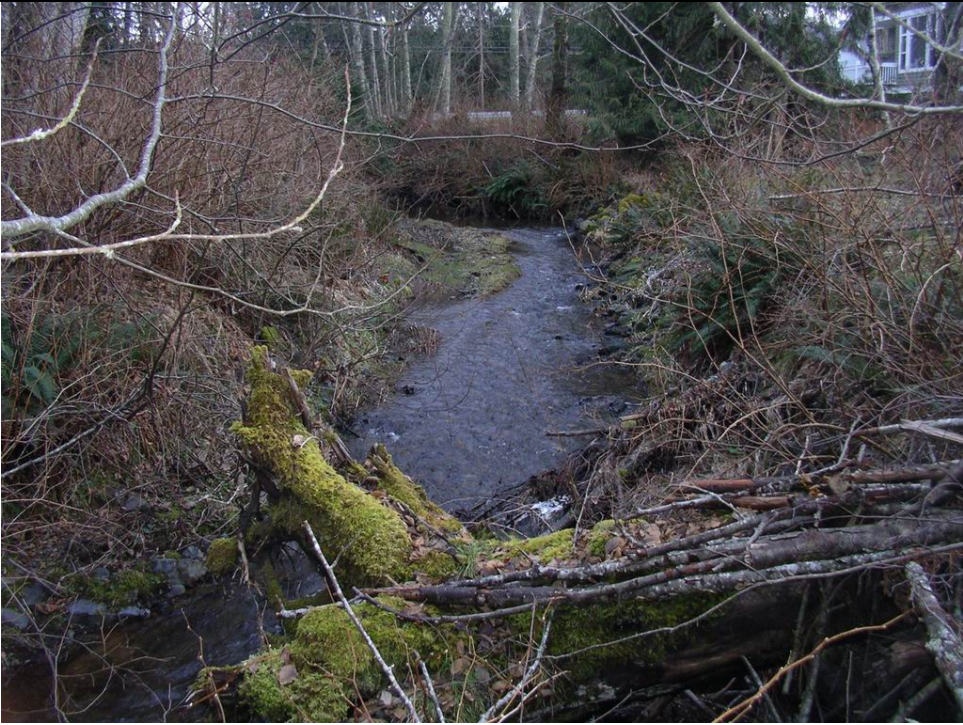
Label	Photo 1. Feb. 14, 2008. Looking upstream at Craig Creek just downstream of Northwest Bay Road (Craig Bay Estates on right).

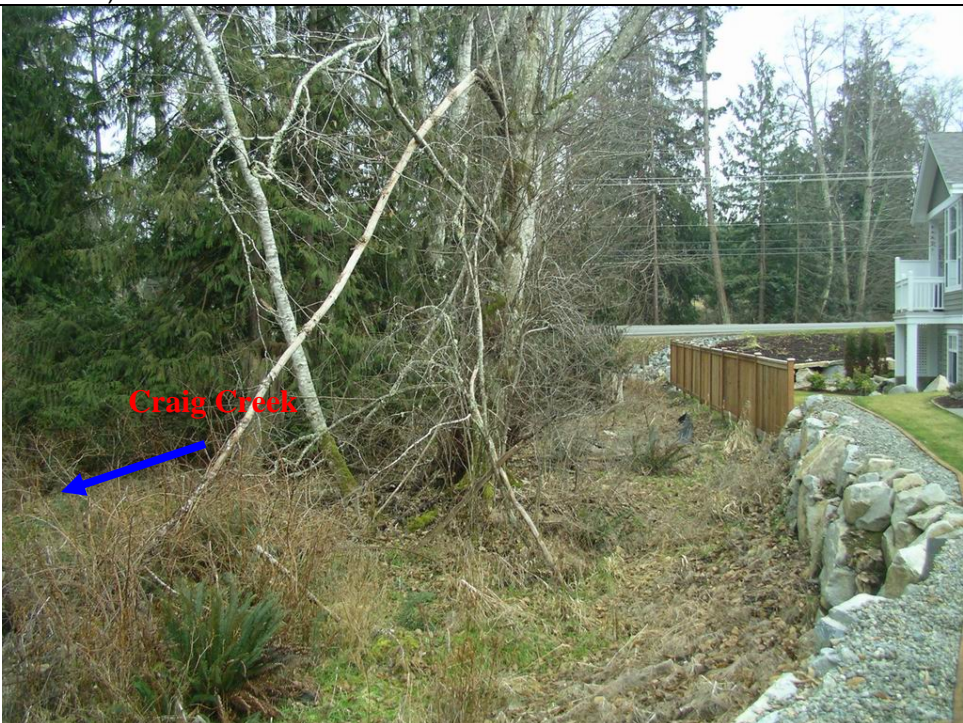
Label	Photo 2. Feb. 14, 2008. Looking south at southeast corner of Craig Bay Estates (Craig Creek on left).

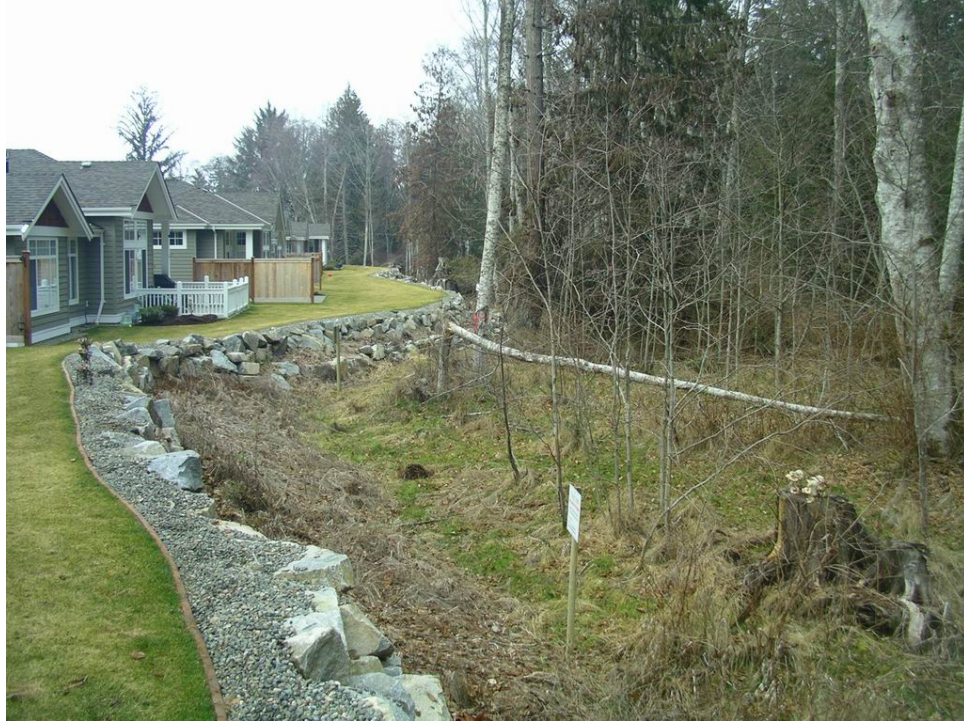
Label Photo 3. Feb. 14, 2008. Looking north along eastern boundary of Craig Bay Estates. Dangerous trees are located sporadically along the right. The fallen alder in the photo is indicative of the potential danger in this area. Note the relative lack of coniferous trees and understory in this area.

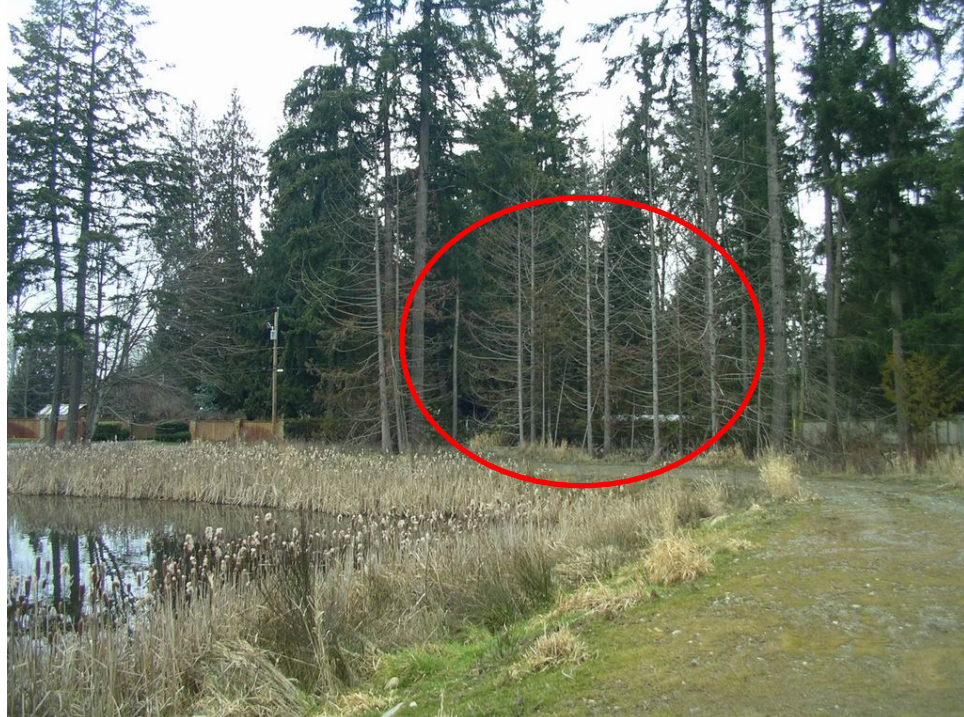
In addition to the danger trees, there is a patch of 9 dead western redcedar trees at the northeast corner of Craig Bay Estates (just south of Bay Road). These trees are within the 30 m Riparian Assessment Area of the wetland associated with Craig Creek. These trees are also adjacent to the constructed stormwater detention pond at Craig Bay Estates. It is likely that these trees died in response to soil and groundwater disturbance from construction of the area around the stormwater detention pond. While these trees are not currently dangerous, they will eventually become dangerous to pedestrians along the trail that borders the detention pond. As such, it is proposed that the trees be topped and the branches thinned out. This will reduce future hazard potential, enhance wildlife value (provide enhanced perching sites for birds) and will increase the aesthetics of this area. Conifer seedlings will likely be planted here by Craig Bay Estates, but this is not a requirement as the dead trees are not being removed.

Label Photo 4. Feb. 14, 2008. Looking north at group of 9 small, dead cedar trees at northeast corner of Craig Bay Estates (constructed wetland on left, natural wetland to the right).

The treatment of the 9 small, dead cedar trees adjacent to Bay Road does not require a tree replacement plan as these trees are not to be removed. It would not be appropriate to remove these trees unless they were determined to be dangerous at a future date. Planting of western redcedar seedlings or other native trees in this area is encouraged. The trees likely died as a result of development, but they continue to provide some ecological function and a visual barrier between the trail and Bay Road. Planted trees would replace the loss of trees that occurred here and would eventually green up and enhance this visual barrier. In the meantime, treatment of these trees would enhance their value to birds, especially given the proximity to a large constructed wetland.

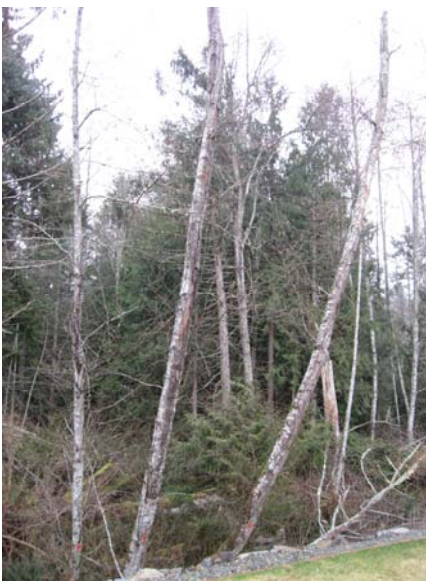
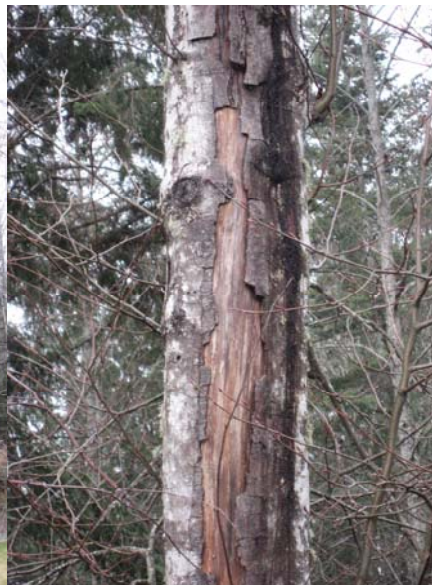
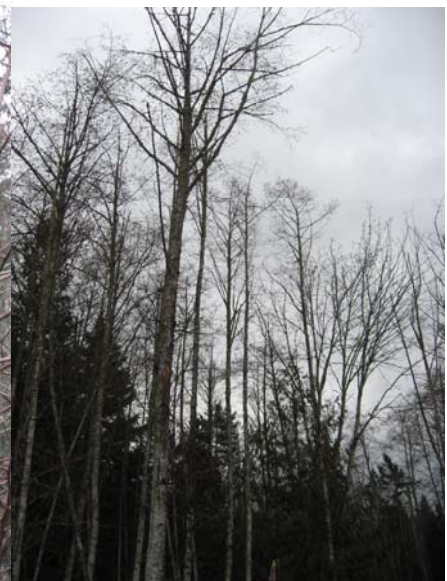
Trees # 2,3,4 and 5 are Red Alders leaning towards residences. They are in poor health with dead flaking bark. These trees should be removed.

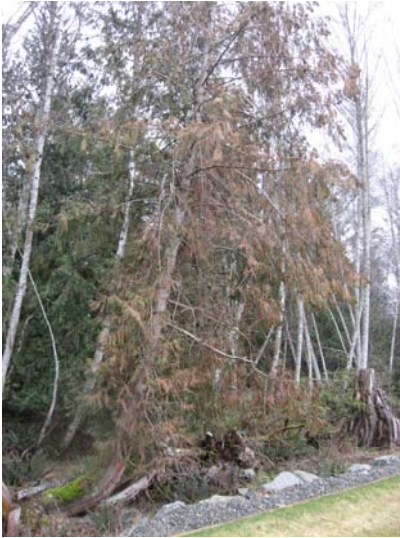
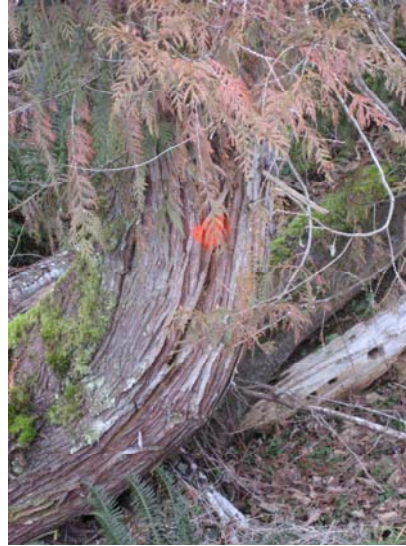
Tree # 6 is a Western Red Cedar (*Thuja plicata*) which is the process of failing. It has a swept root crown which has split and has a deep crack in it. The crown is dying and this tree should be removed.

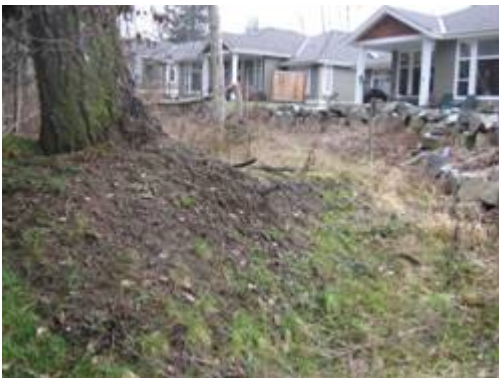
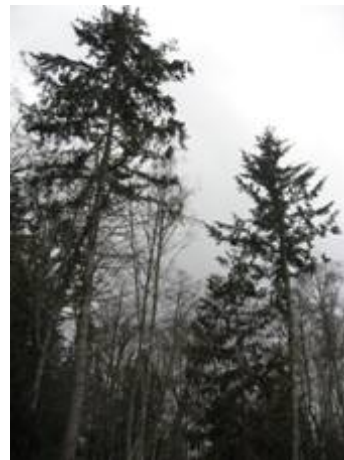
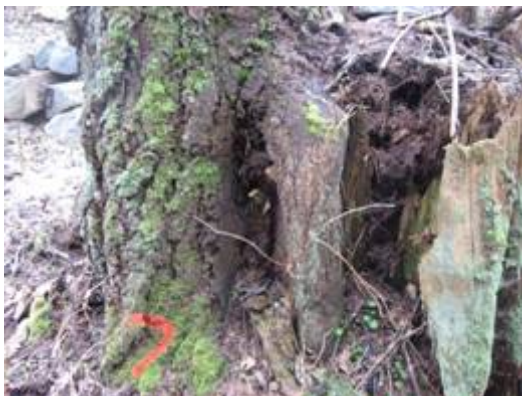
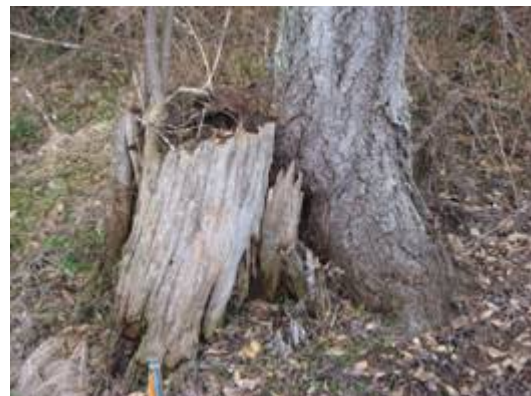
Trees # 7 and 8 are Douglas Firs (*pseudotsuga menziesii*) which appear to be healthy except for the condition of both root crowns. Tree # 7 has grown beside an old Cedar stump and this old stump has interfered with the firs root development in this quadrant of the root zone. Tree # 8 has had the natural grade of the soil altered during the construction process. The soil has been excavated into the critical root zone and the tree has most probably suffered root damage. This could possibly lead to whole tree failure in both circumstances. Both these Douglas Firs should have their crowns spiral pruned by 25%. This procedure reduces the sail effect of the tree in periods of high wind and helps to reduce the effects of leverage on the root structure.

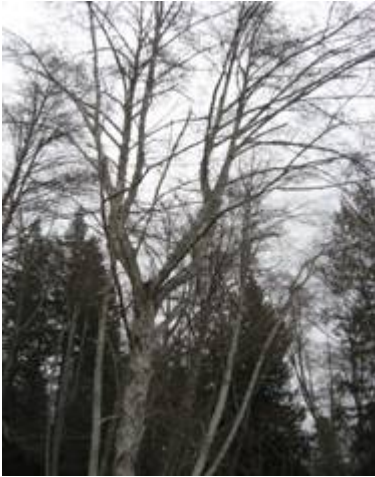
Tree # 9 is a Red Alder. This tree had its leader broken off many years ago and now has four tops growing from the old failure point. This crotch will most probably have substantial decay and rot. These new tops will be poorly attached to the main stem and are a hazard. This tree should be removed.

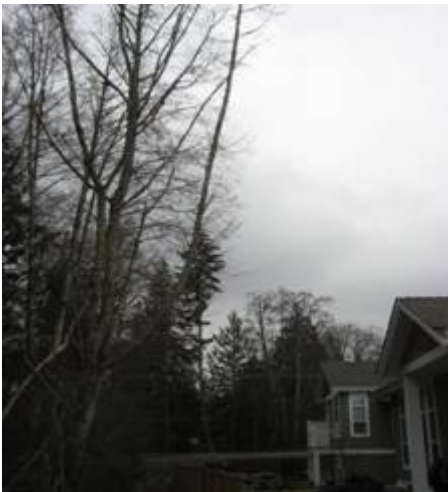
Tree # 10 is also a Red Alder. This tree is in poor condition with dead flaking bark where the tree has a co-dominant stem. There is also a large leader targeting the residence below it. This tree should be removed.

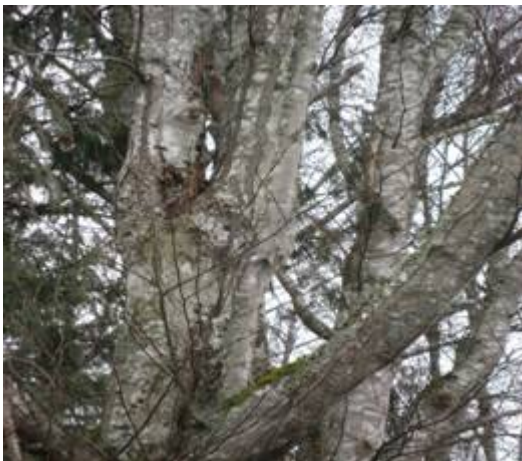
The Red Alders described in this report are all in decline presenting imminent danger to people and their property. These trees are nearing the end of their life cycle and this is why there are decay pockets, dead limbs, and flaking dead bark present. All trees which are to be removed should be left as wildlife stumps as long as it is safe for the contractor and its crew.
